# Jobling Purser Limited Case Studies

## LUCIOL (Class 1) Case Study

### Stockton-on-Tees Borough Council

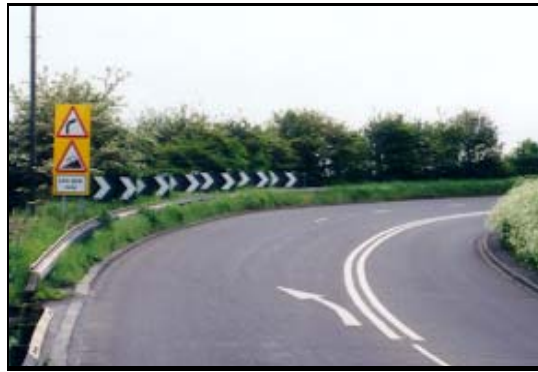
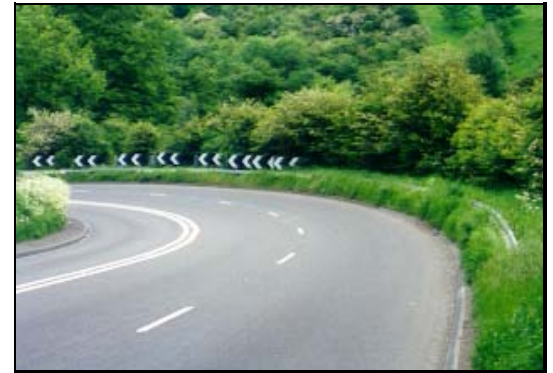
**Site Description:**

Sharp bend at bottom of steep hill descending from blind summit. Road narrows to bridge 100m after bend. De-restricted A class road.

1. Installation of Luciol to existing box beam section safety barrier.
2. Additional/improved signing and road markings.
3. High friction surfacing installed 1995.
